## **Prairie County Tornado Event May 20, 2011 National Weather Service Glasgow Storm Survey Summary**

# Public Information Statement Issued 5/22/2011

...FINAL DAMAGE SURVEY RESULTS FOR TORNADO SOUTH OF TERRY MONTANA...

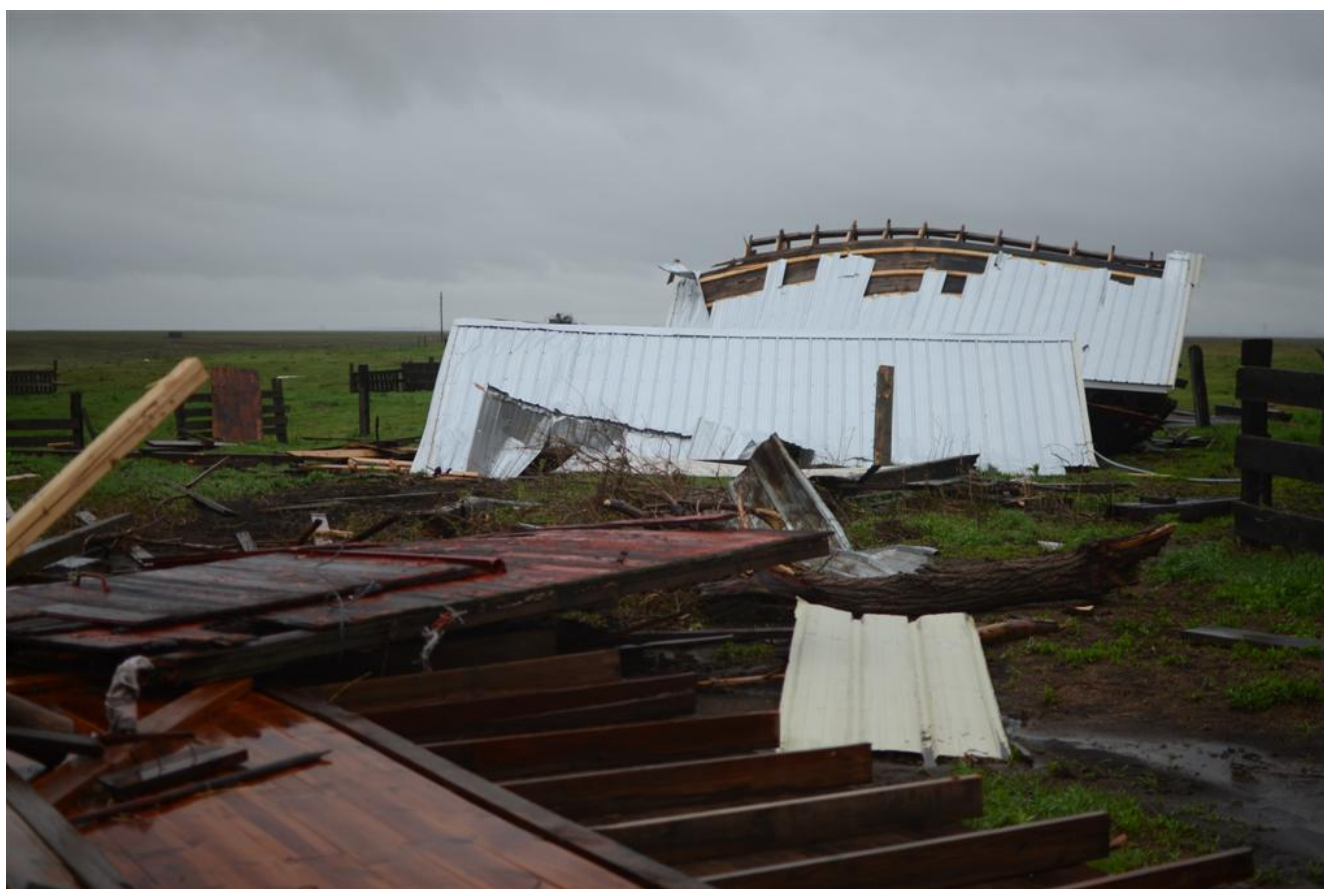
Fig. 1. Damage to two barns on ranch. Debris from Old Barn2 is in the foreground and the roof of New Barn is in the background.

New Barn and Old Barn2 (seen in Fig. 1) were severely damaged with Old Barn2 completely flattened and debris strewn some distance from the foundation. New Barn was of new construction and had the walls blown out. Some debris was blown downwind to 150 yards westward.

The damage indicative of the highest wind speeds was the collapsed walls of the New Barn and the snapped tree. These are consistent with a rating of EF-1 on the Enhanced Fujita Scale.

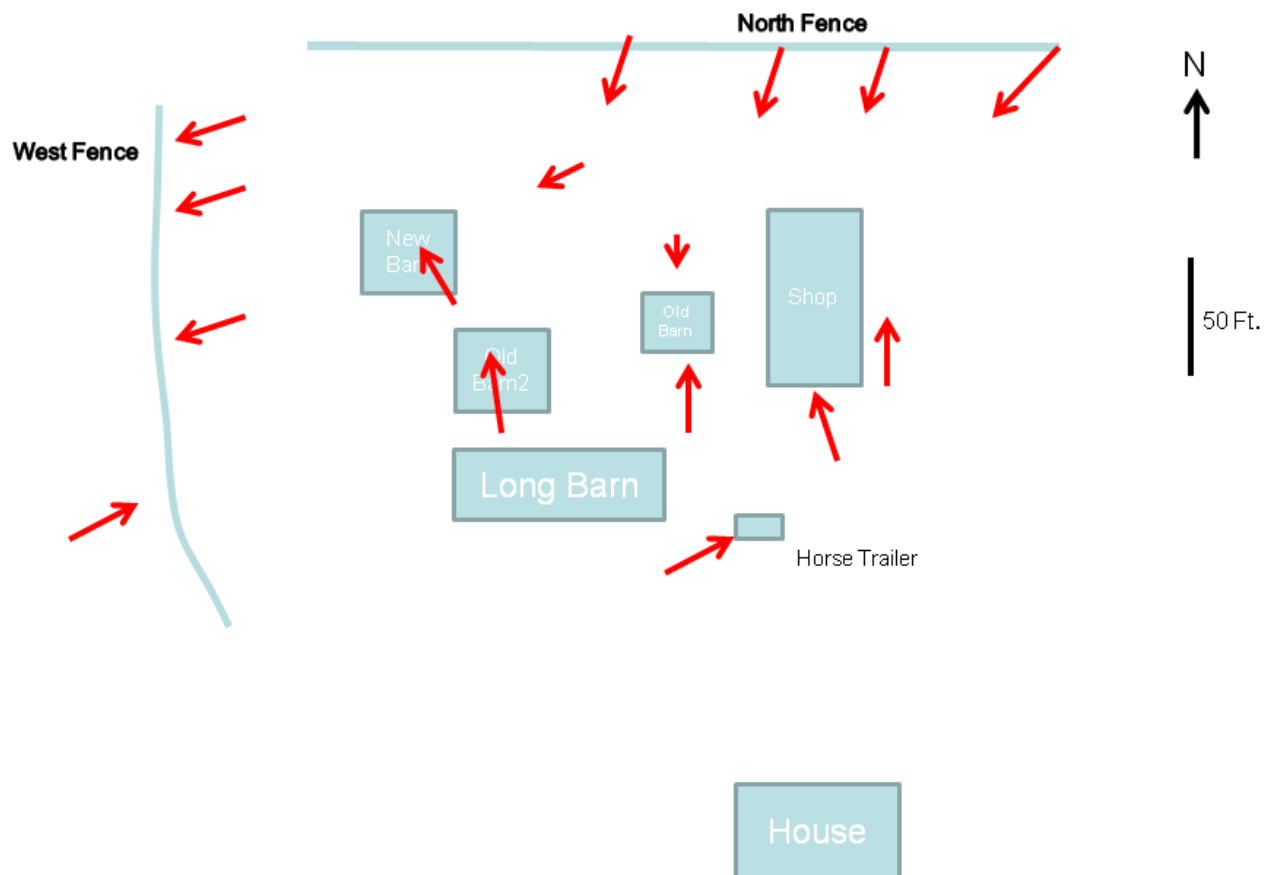
Figure 2 shows a diagram of the buildings on the ranch. Red arrows in Fig. 2 indicate the approximate flow direction implied by debris movement. Names have been assumed for objects in Fig. 2. No damage occurred to the House or the Long Barn.

Fig. 2. Overview of Capp ranch. Red arrows indicate approximate direction of damage flow.

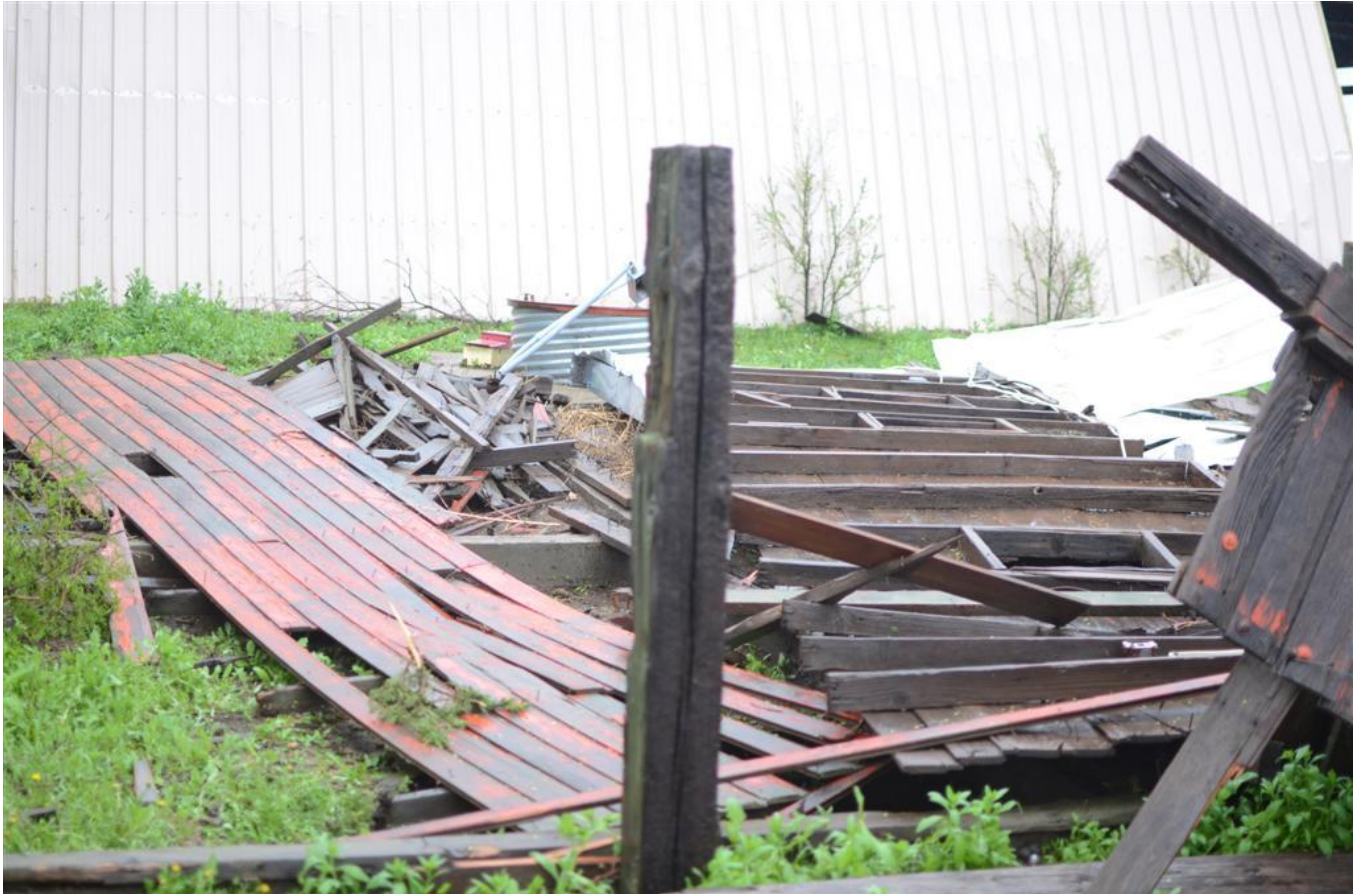
Old Barn was completely demolished without much debris movement, though the walls were generally blown inward (Fig. 3). The Horse Trailer was moved about 20 feet to the northeast. A line of trees were toppled just inside the North Fence (Fig. 4). As the ground was saturated from recent heavy rains, the trees were uprooted relatively easily, without any loss of leaves or branches.

Fig. 3. Damage to Old Barn

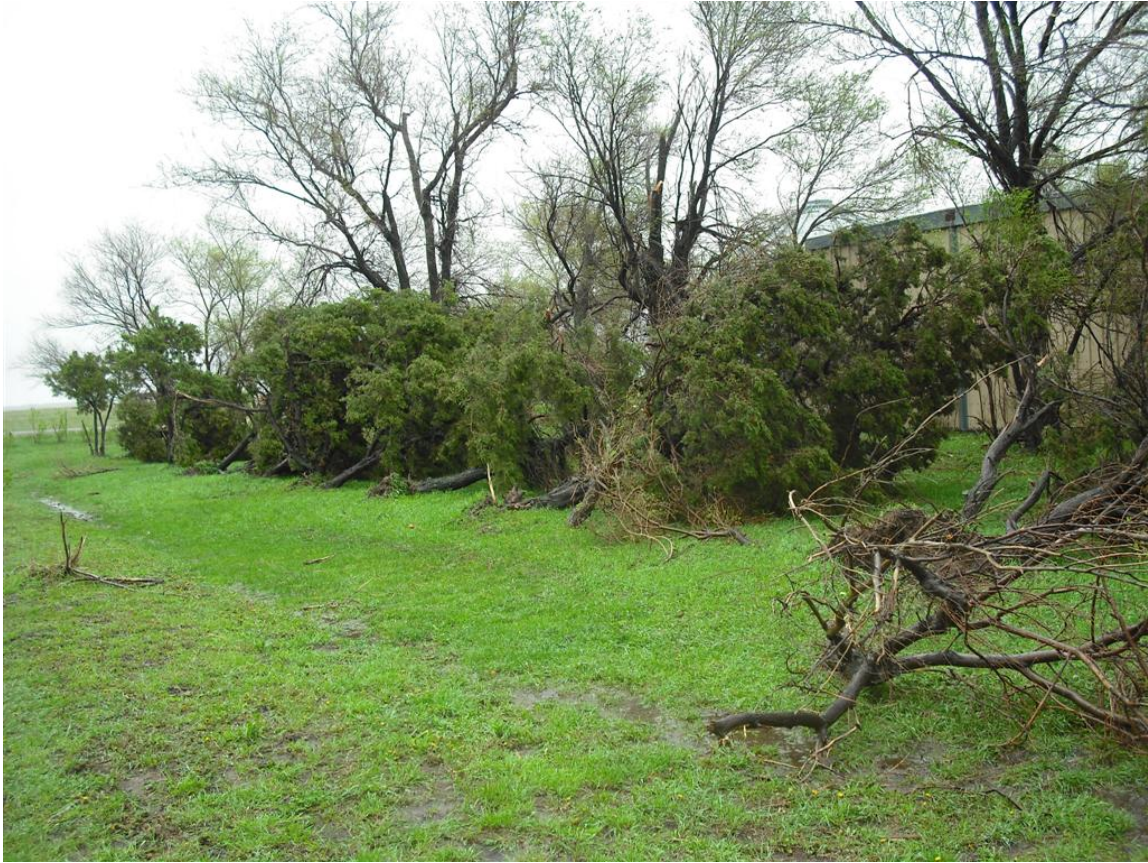
Fig. 4. Line of trees uprooted just south of the North Fence . Photo by John Pisk.

The convergent and localized damage path, combined with the eyewitness account, confirmed the presence of the tornado. The movement of the Trailer towards the northeast, combined with the southwestward fall of the trees south of the North Fence cannot be explained by any sort of straight line wind event.

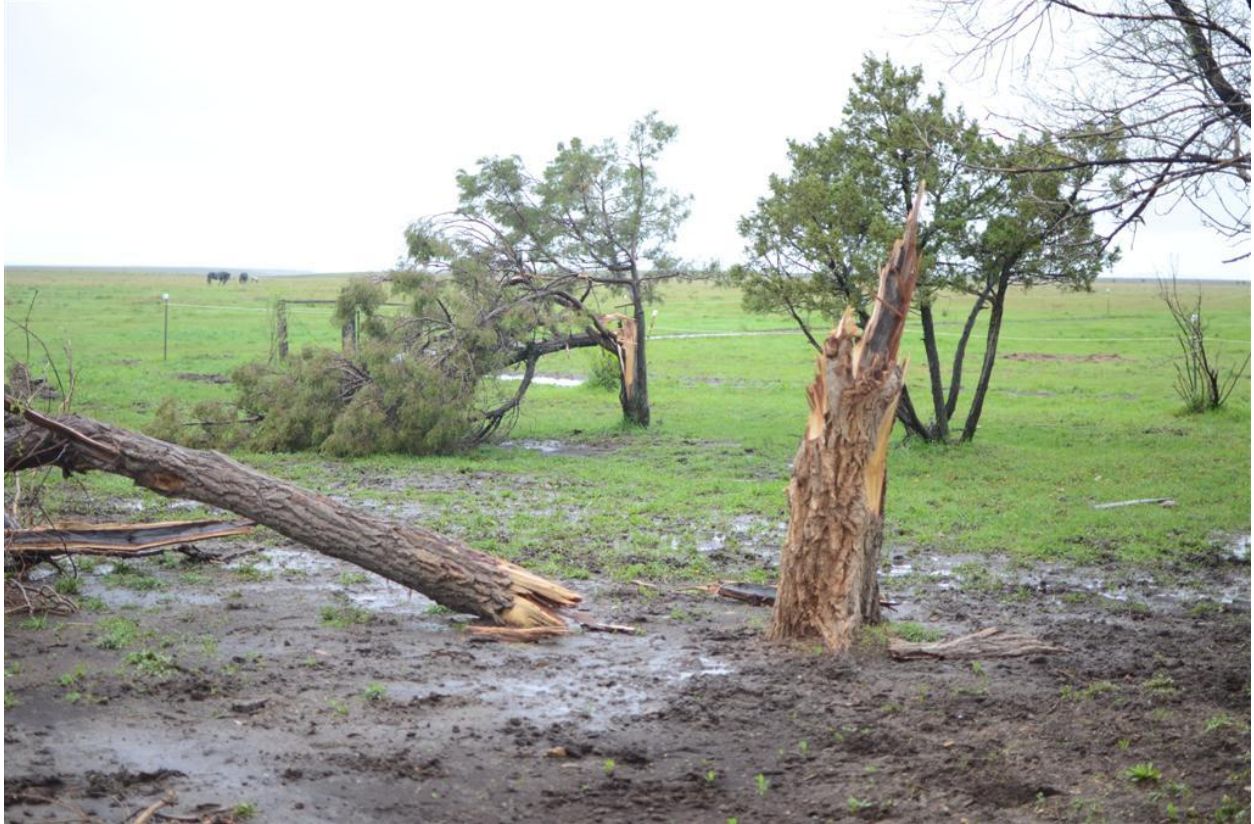
A larger tree was cleanly snapped northeast of the New Barn location (Fig. 5). Several horizontal sections of the wooden West Fence were blown out (Fig. 6). North sections of the West Fence were blown out westward, while one section of the fence on the south side was blown eastward.

Fig. 5. Tree snapped northeast of the New Barn.

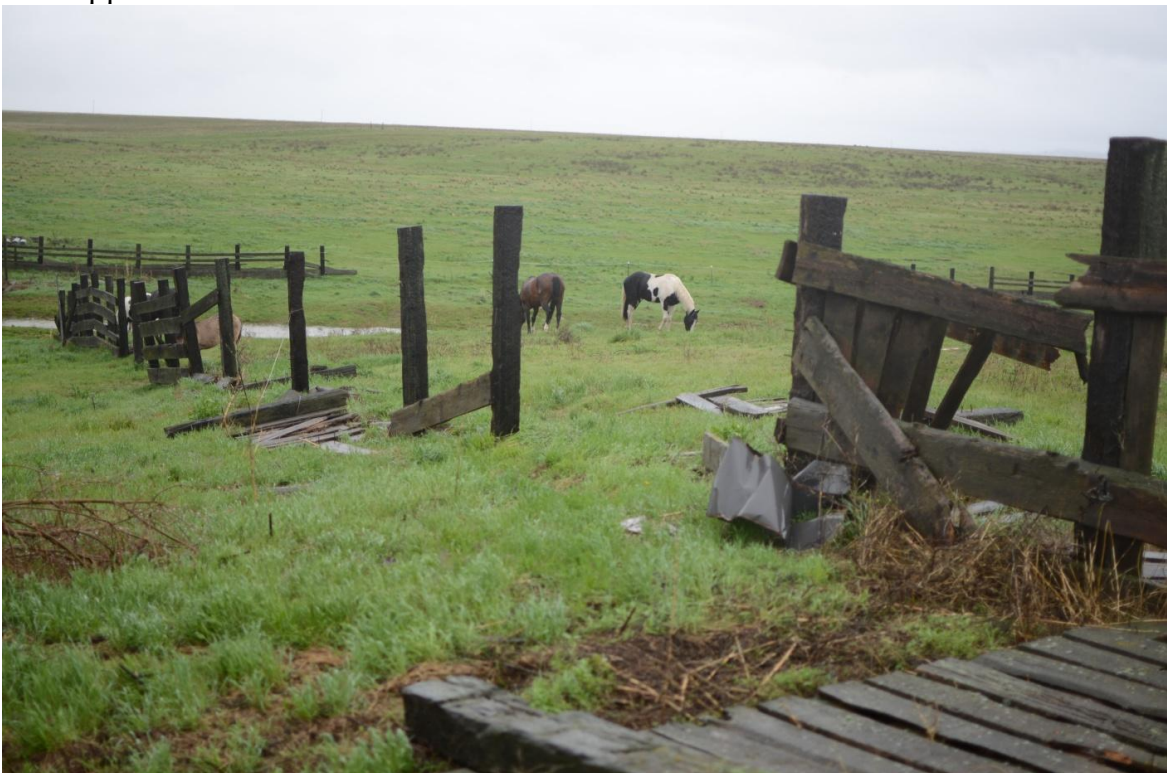
Fig. 6. Damage to West Fence. Near damage was blown westward (right of image), while far damage was blown eastward.

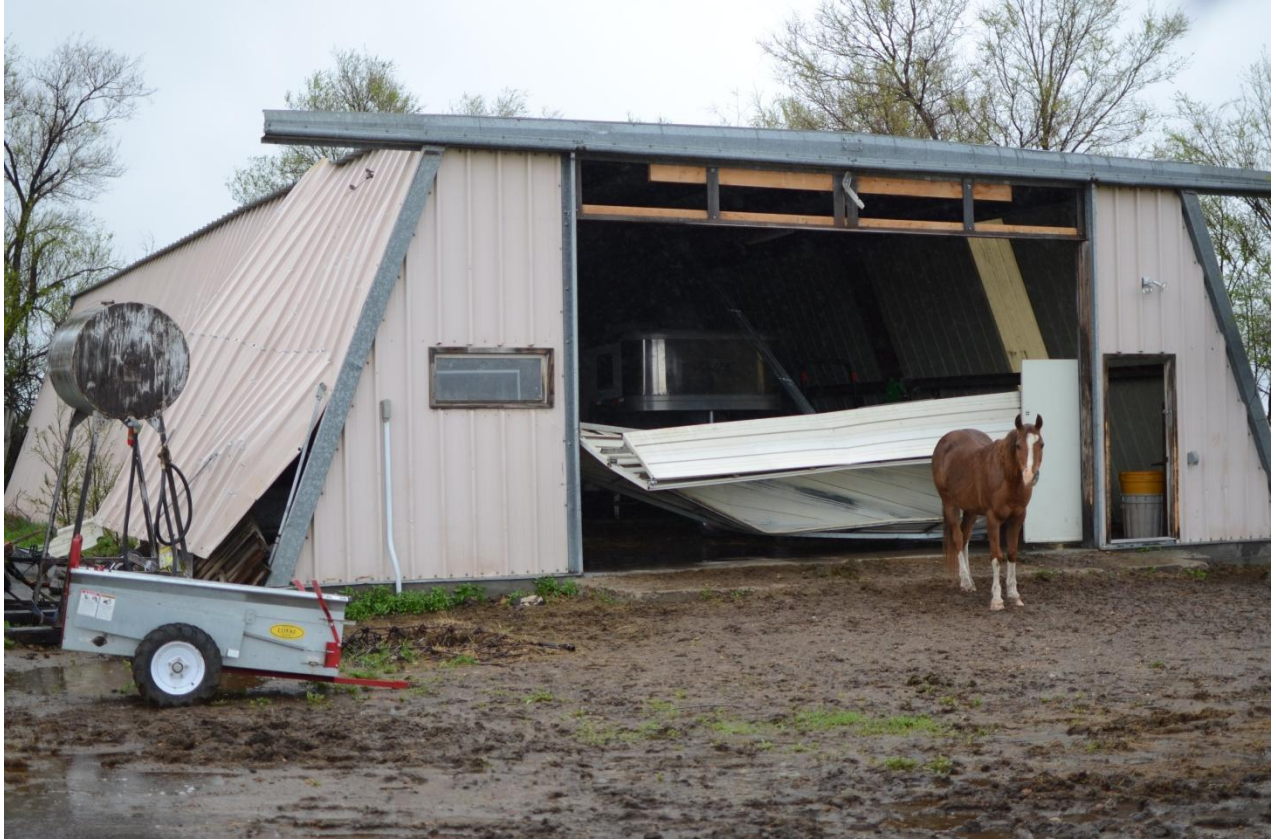
The large front door of the Shop was blown in (Fig. 7) and part of the west wall was blown out. In addition, most of the support beams of the shop were damaged (Fig. 8).

Fig. 7. Damage to Shop with door blown in.

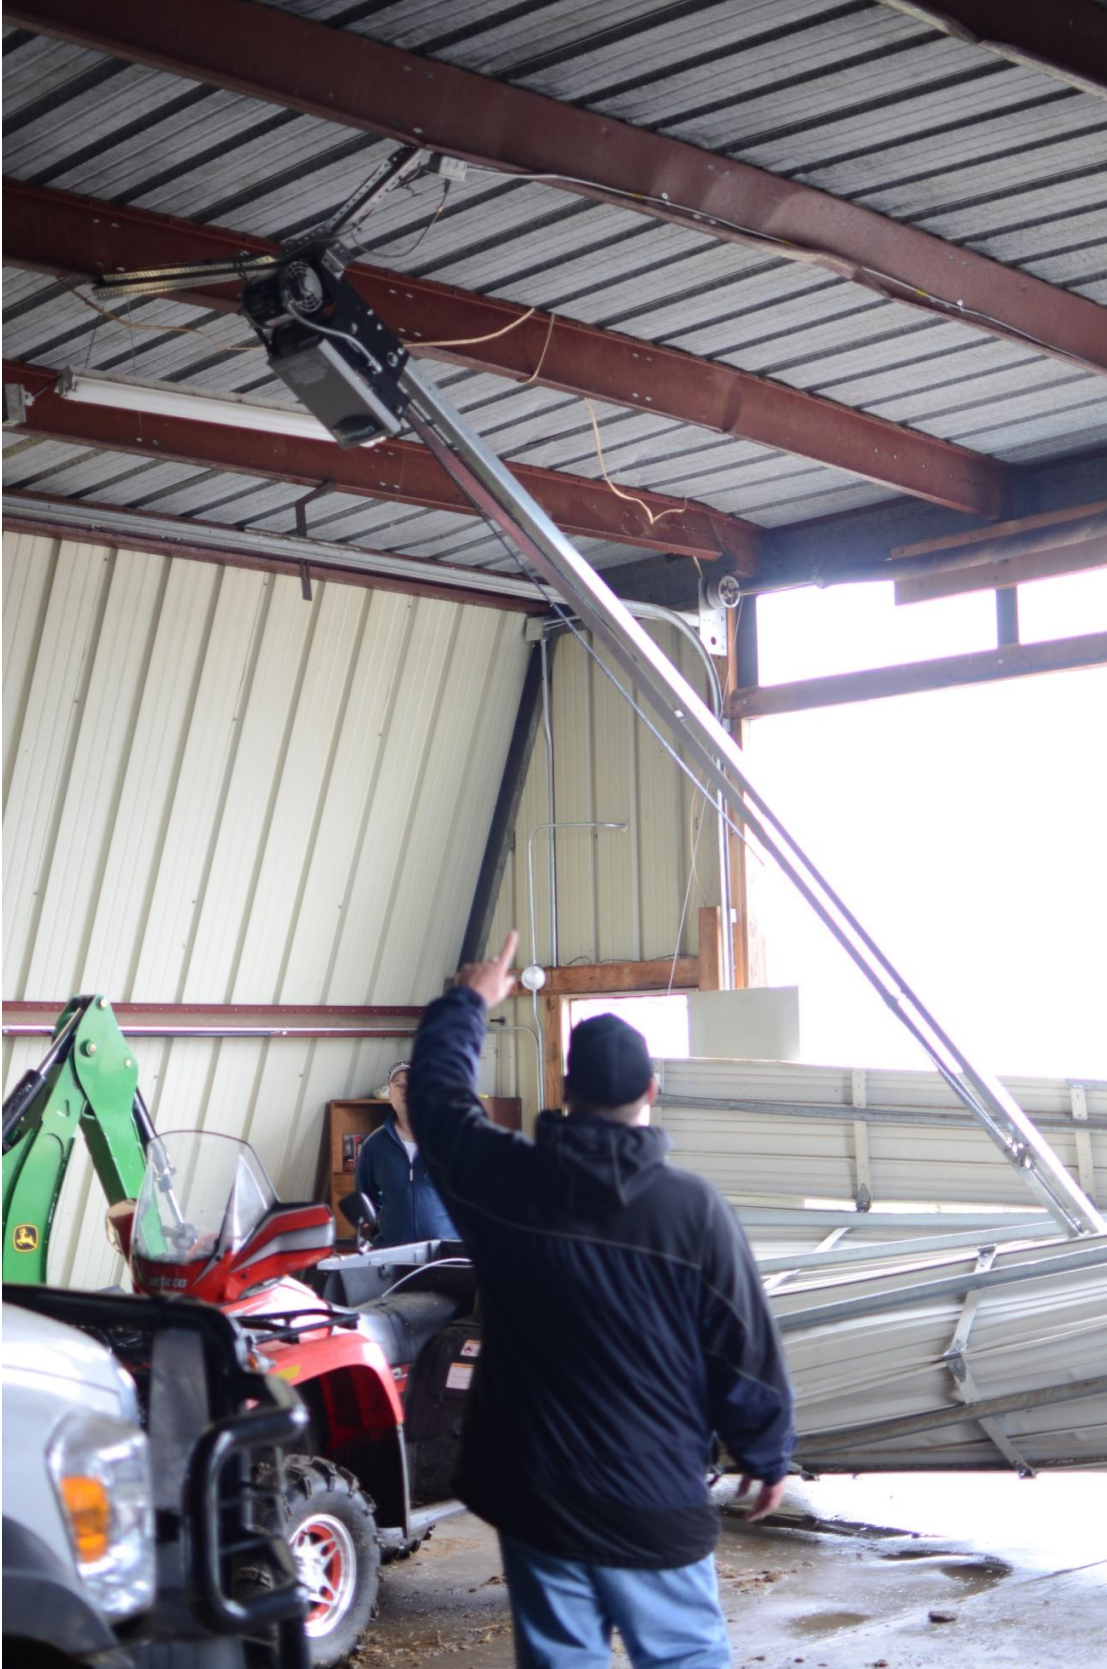
Fig. 8. Damage to Shop showing distorted I-beams.

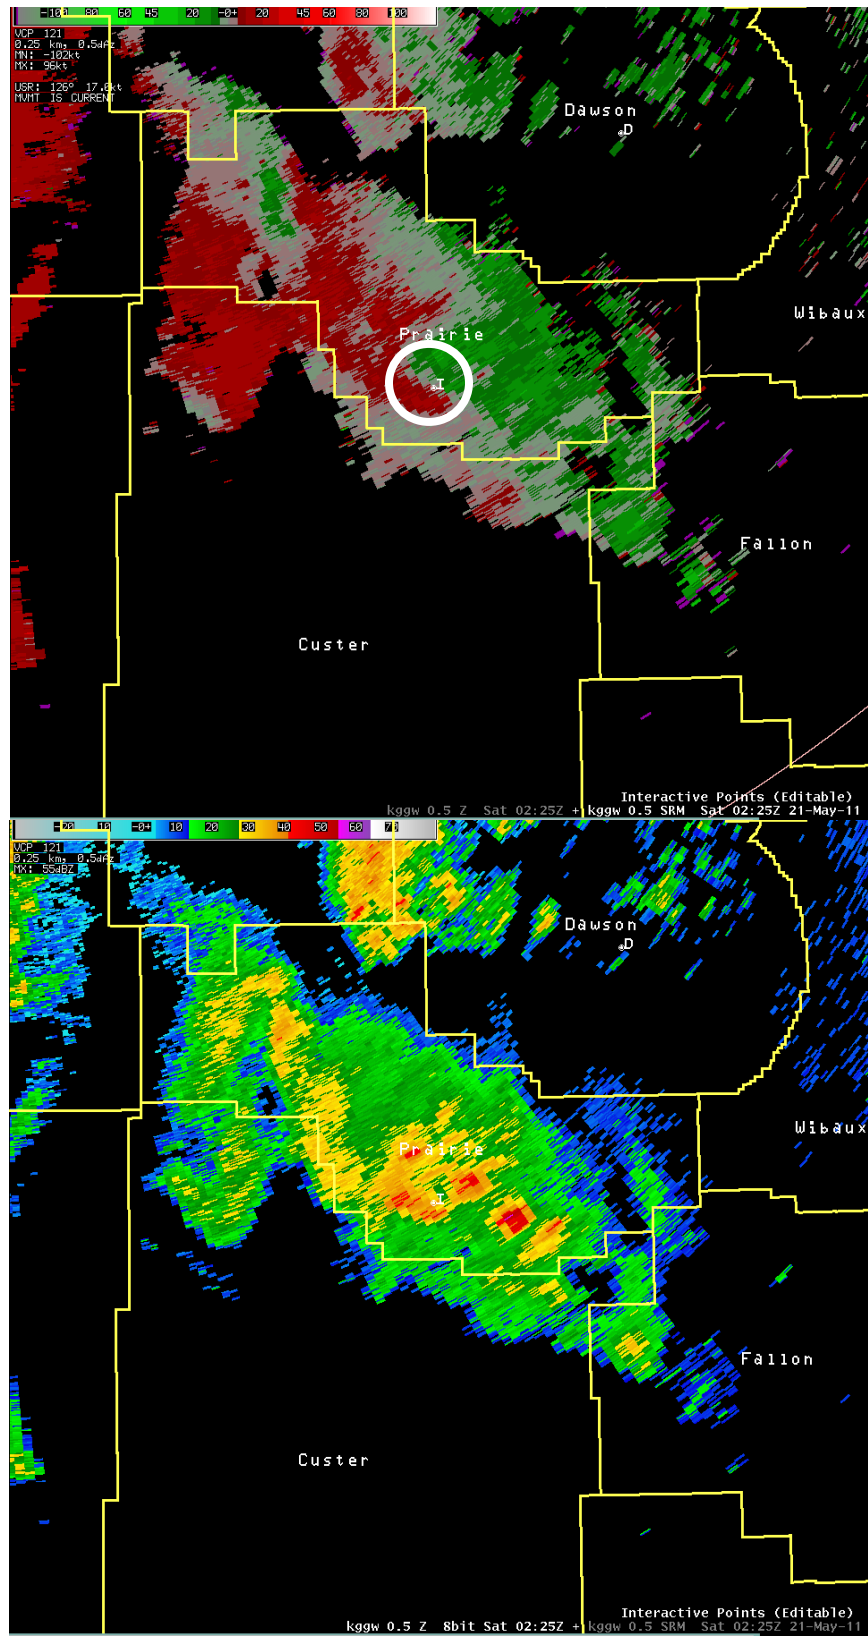
Fig. 12 shows the radar data for reflectivity and storm-relative radial velocity from the KGGW radar at 8:25 pm, about the time of the tornado. The tornado was a considerable distance from the KGGW radar, at a range of 122 miles. At this distance, the lowest available radar tilt (0.5 degrees) put the beam 13 000 feet above ground level. Consequently, it was not possible to see most of the structure of the storm with the radar. Still, it is noteworthy that the radar did detect a weak mesoscale circulation exactly over the tornado location at the time of the tornado (white circle in the top of Fig. 12). The velocity couplet of this circulation was about 30 kts. This circulation was present in radar data from about 15 minutes before the tornado to 30 minutes after. It should be noted that such weak circulations are common and are scarcely distinguishable from turbulent eddies. The circulation was not strong enough to trigger the automated mesocyclone detection algorithm, nor any interest from the radar operator.

The reflectivity pattern shown in the lower part of Fig. 12 does not show any cause for concern either. Maximum reflectivity values are modest, with no obvious storm structure. It is noteworthy that a cell that was more intense than the ones over the tornado location was seen on radar about 10 to 20 miles east of the tornado location. This cell collapsed at about the time of the tornado. It is likely that the collapse of this cell was responsible for a separate damaging wind report that was received for 16 miles SE of Terry at the same time as the tornado. One can speculate that the outflow from the collapsing cell may have interacted with the area of weak meso-rotation to generate the tornado. The tornado report and the wind damage report were the only severe reports received in that area all day. That these reports were within 10 miles of each other and at the same time suggests a relation; however, there is no way to know for sure as the radar data is inadequate.

This tornado was undetectable and unwarnable with current radar technology, mostly because of the large distance from the tornado to the radar location combined with the small size of the tornado. Had the radar been closer to the tornado, higher resolution data would have been available, as well as data much closer to the ground. Were that the case, a velocity couplet directly related to the tornado would have been observed.

Fig. 12. KGGW radar data from 8:25 LT. SRM (top) and reflectivity (bottom). Weak mesoscale circulation indicated by white circle in SRM plot. Location of tornado indicated by plotted "I".
